Machinery Messages

Protection against thrust bearing failure in a steam turbine

by Charlie Jackson
Turbomachinery Consultant

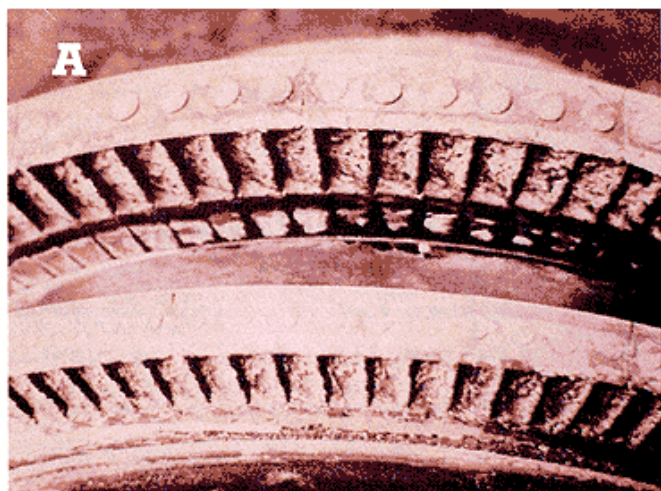
These exchangers leaked, contaminating the steam quality with sodium chloride. The ten stage turbine developed salting problems when brine and treated water contaminated the boiler feedwater due to leaks in the internal exchangers of a flash evaporator. The salt, primarily sodium chloride (table salt), settled out selectively on the fifth and sixth stage blading, obstructing the flow to a 40 percent, or less, flow passage area. The dew point was 500-525°F (260-274°C).

(A) Closeup of the fifth and sixth stage blading showing salt buildup which obstructed flow to 40 percent.

The rotor was cleaned. The contamination to the boiler feedwater was corrected through exchanger repairs. Steam conductivity meters and alarms were installed to monitor steam conditions.

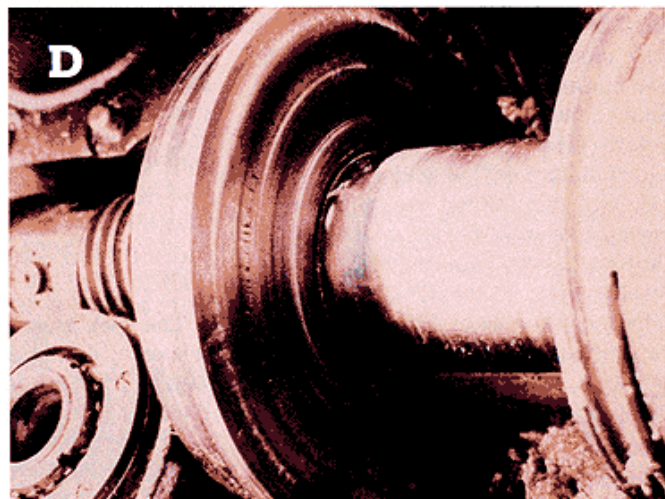
This failure melted the thrust bearings. The rotor thrust face had "severe" heat check tears in the active face. The radial bearing overheated and melted the babbitt [high tin babbitt melts at 415°F (213°C)]. The melted babbitt flowed down the drain oil pipe and solidified, blocking the oil flow. It is fortunate the oil flow was blocked, otherwise plant operators would have restarted the steam turbine if oil flow could have been established.

(D) Damaged active thrust collar. Note: heat tears in the metal and blue color on the journal.

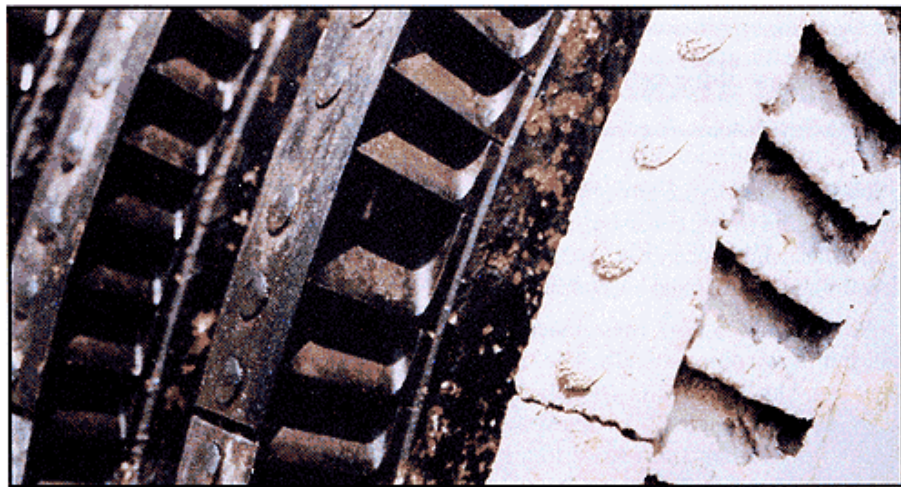
A 1989 incident is a good example of poor conditions leading to back pressure turbine salting and overloading of the thrust bearing on the steam turbine. A turbine received desuperheated steam at 650° to 750° (343° to 399°C), not the traditional 600 psi (4,136,880 N/m²) steam at 700°F (371°C). Usually, the turbine received steam at too low a superheat, between 600° and 650°F (316° to 343°C), so the maximum amount of condensation is returned to the unit's reactor steam generating system. Mineralized condensate from the deaerator and other units also added to the problem.

Figure 5
Salt deposits on last row of Rateau blading.

Steam Turbine Unit 2 was opened to install an improved radial bearing and to repair casing leaks. The last row of 5 Rateau blading was heavily fouled (Figure 5). The thrust bearing shows the overloaded "darkened" areas, confirming that 75% arc and 75% radius remains an accurate placement for the thermocouple. (However, never embed thermocouples into the babbitt!)

The rotor was inspected through the tapped hole for the Sentinel valve, which fortunately looks directly at the last stage bucket (on center pitch). Blade conditions were recorded with a lens/light through the plug for the Sentinel valve. Two selected hydroblast nozzles with reduced water pressure were used to clean the buckets through this opening without disassembling the steam turbine. The area was washed to very good condition while spinning the 10,000 horsepower steam turbine rotor at 70 rpm.
